# **Field Report for Airborne Data Collected In Support of US EPA Region VI International Terminals Corporation Fire 19 March 2019**

Mission: 2019-03-19 International Terminals Corp Fire

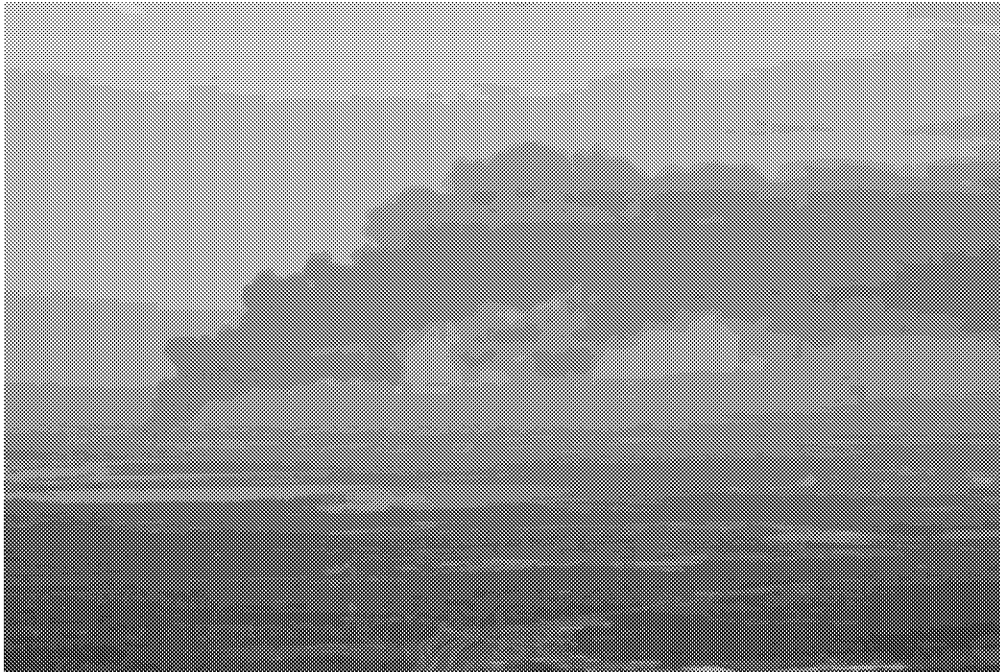
Figure 2: International Terminals Corp Fire, 19 March 2019, Oblique Image

The crew reported that winds at altitude (2800 ft) are at about 19 kts (7 m/s) from about 150 degrees. Smoke emitted from the fire was reported to be gray to black in color and was visible 50 miles from the facility. The plume was reported to still be rising but was lofting less than on 18 March 2019. Figure 2 shows a representative oblique image. Note that the plume is showing some vertical displacement indicating that upper air mixing is beginning to impact the dispersion of the plume. In general, the plume is occupying a region from 1500 feet AGL to about 5000 feet AGL. Plume motion was consistent with the reported winds at altitude or movement towards the northwest.

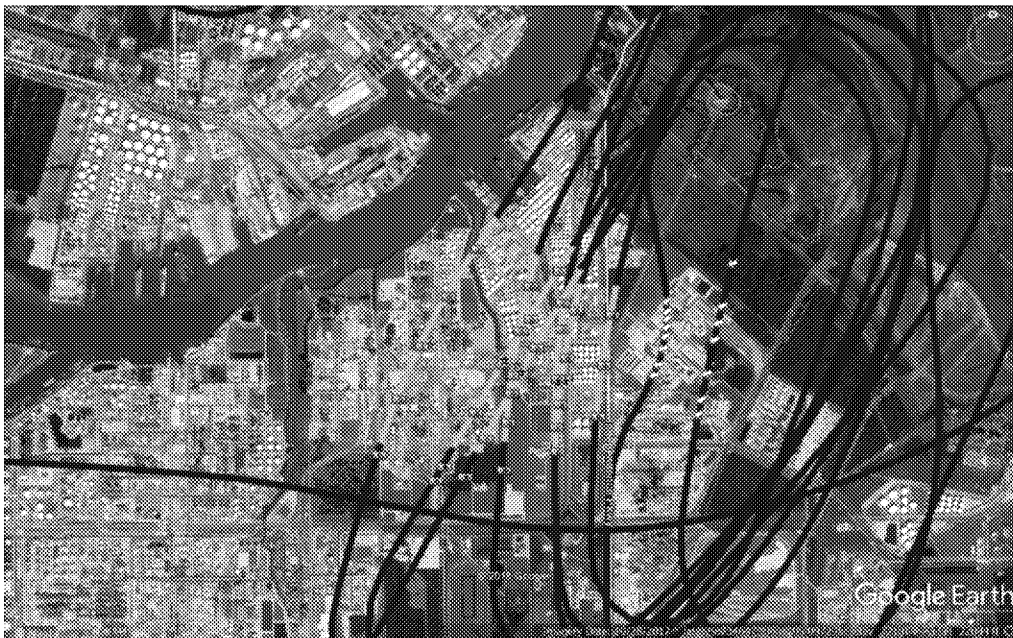
The order to launch the aircraft was given at 0700 local on 19 March 2019 and the aircraft was airborne at 0718. The initial data collection run over the site was at 0855 (local) The aircraft made a total of 12 data collection passes; flight information is summarized in Appendix A and Figure 4A and 4B.

Figure 4A: Flight lines in the immediate area downwind of the fire.

Figure 4B: Flight lines in the extended downwind area of the fire.

Notes for Figure 4A and 4B: The blue lines represent the ASPECT flight path, green lines represent when the Infrared Line Scanner was actively collecting data, and the camera icons represent when a photo was taken.

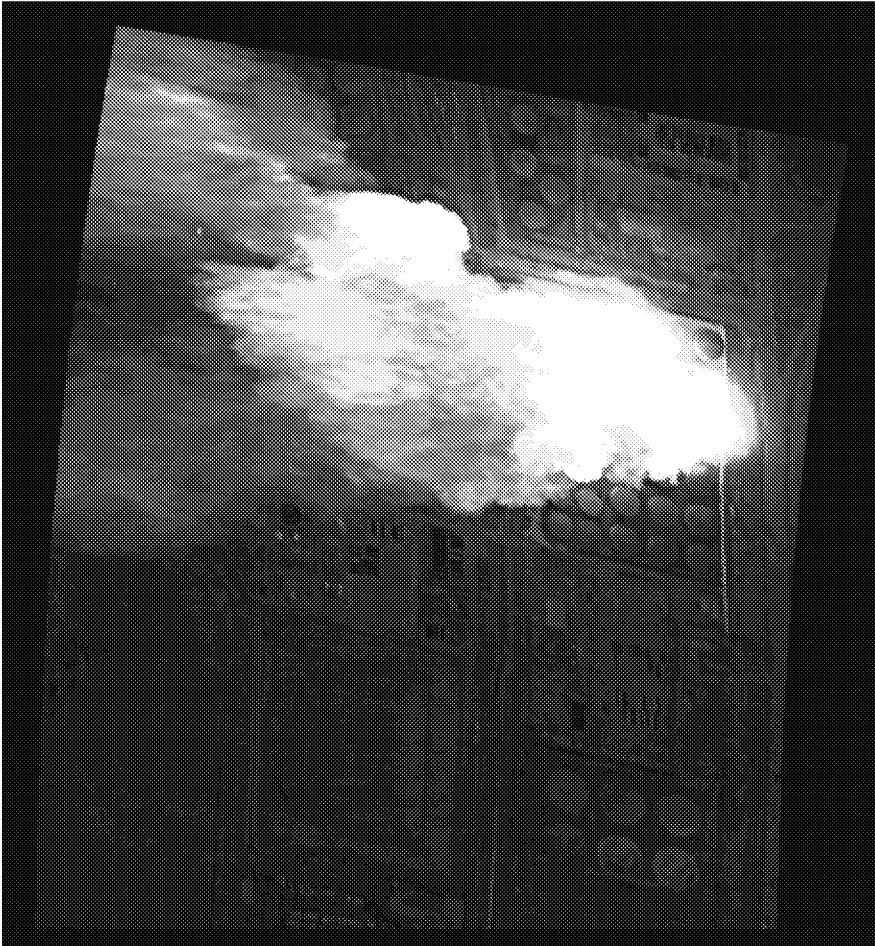
Figure 6: IR image International Terminals Corp, 19 March 2019, Run 6

A total of 2 test and 8 data passes were made in the proximity of the site and an infrared line scanner images were generated for each pass. Figure 5 shows a typical 3-band infrared image obtained from data collected for Run 6. The overall thermal signature of the fire is very large. A qualitative analysis of the image indicates that the region of total saturation of the detector (white) is roughly 280 meters across (north to south) and about 600 meters in length. As with prior flights almost total obscuration of the ground signal is being masked by heat and/or particulates. Figure 7 shows a comparison of IR data collected on 18 March 2019 (left) and 19 March 2019 (right). The

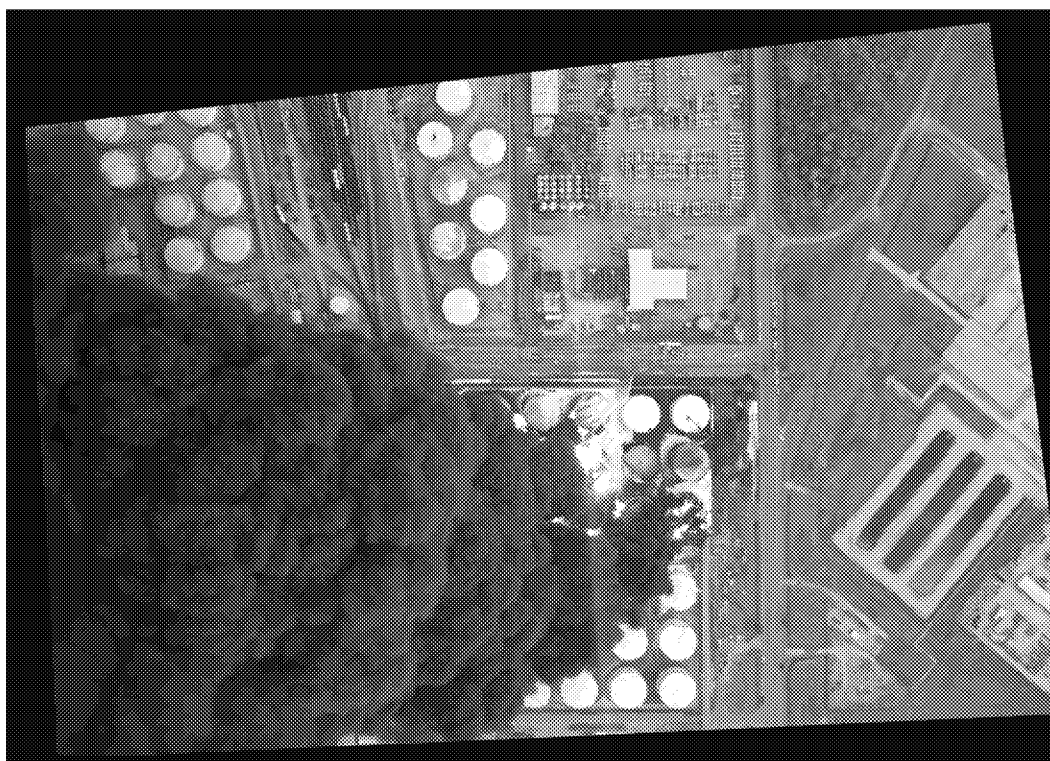
Figure 7: Aerial Image of the International Terminals Corporation Fire, Flt 3

A full set of high resolution aerial digital photography were collected as part of the flight. Figure 7 shows a representative overhead image collected as part of each pass. Figure 8 illustrates a typical oblique image. Both images confirm the finding that the fire is much more involved than on prior days with most of the tanks in the tank farm on fire.
